Towards Restoring Infiltration in Permeable Pavers—Initial Demonstration of Rapid Clean-Out Concepts

William James¹ and Harald von Langsdorff²

Abstract

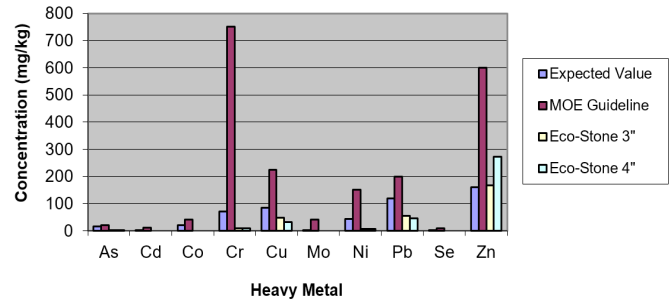
Heavy Metal Concentrations for Eco-Stone 3" and Eco-Stone 4" Compared to Ontario Ministry of the Environment Guidelines

Figure 1 Comparison with the Ontario MOE guideline concentrations for selected metals in soils (blue = expected value; purple = MOE guidelines; yellow = EcoStone 3 in.; green = EcoStone 4 in.).

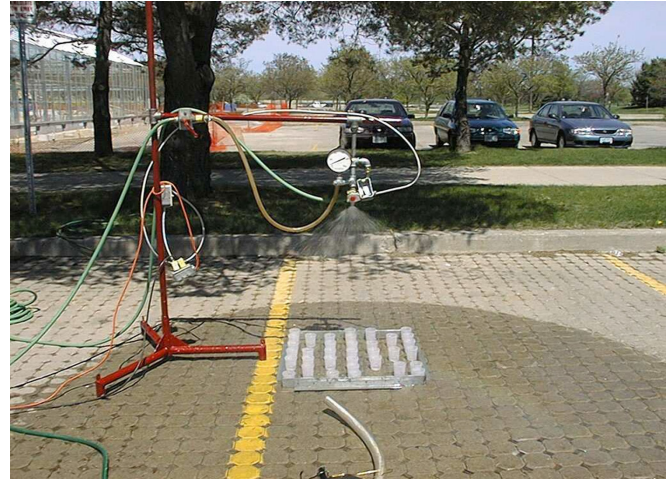
Figure 2 Rainfall simulator for surface infiltration tests on the parking lot test pavements.

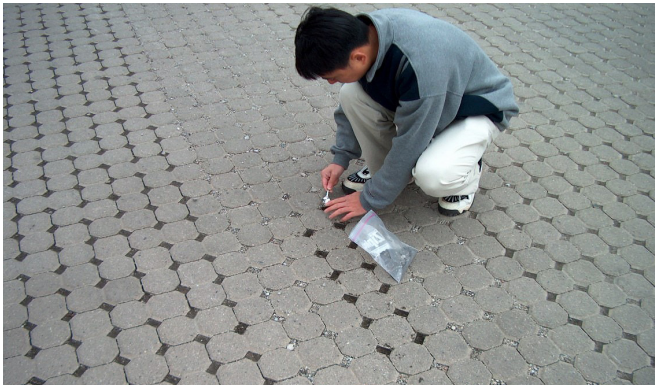
Figure 3 Manual removal and capture of filter and filtrate material in the drainage cells of permeable pavers.

were used over the 8 y period, other than routine snow removal and street sweeping with rotating brushes annually in spring and fall. In their tests, infiltration rates were tested before and after material was extracted from the EDCs and replaced by fresh aggregate. Extracted material was subjected to a particle size and constituent analysis and tested for a number of different organic and chemical constituents such as heavy metals, nutrients and organic matter. By manually removing the drainage cell material, as shown in Figures 3 and 4, and by repeating the infiltrometer measurements at each layer, they again confirmed that infiltration capacity decreased with increasing average daily traffic counts, and as the amount of organic matter and fine matter in the EDC material increased. Furthermore, the tests indicated that the infiltration capacity can be significantly improved by removing only the top 10 mm to 25 mm EDC material, a removal depth that was deemed achievable. Results are shown in Figure 5. Later research confirms the findings in this figure (Gerrits and James 2002).

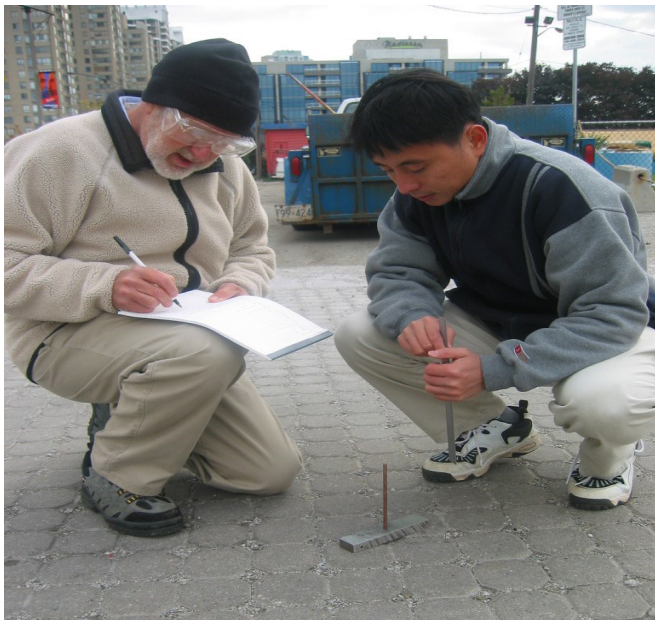
Figure 4 Measurement of removed depths of filter and filtrate material in drainage cells.

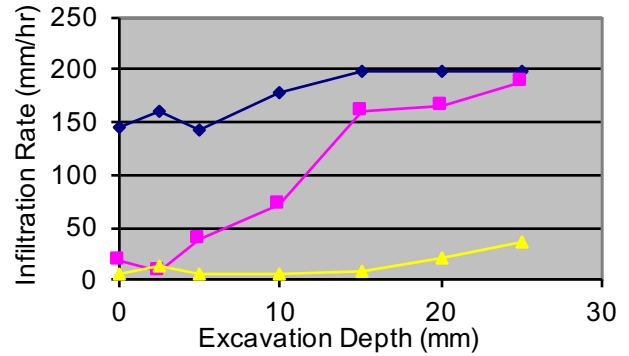
Figure 5 Infiltration capacity vs depth for MICBEC3 installation; the maximum rain rate that could be applied was 200 mm/h (blue = low ADT; purple = medium ADT; yellow = high ADT).

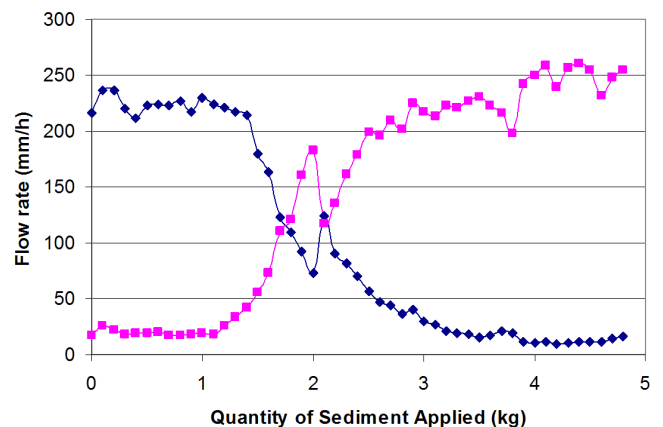
Figure 6 Summary of the change in the peak base drainage and surface runoff due to SD&D application (squares = peak base drainage, diamonds = average peak surface runoff; the anomalous blip at 2 kg is the result of a weekend delay in the experiment).

James (2004) studied clogging of PICPs in a full-scale outdoor test rig having a pavement surface area of 1 m². Samples of parking lot dust and dirt (D&D) were collected from existing PICP installations and processed to remove moisture and volatile compounds, as well as biological vectors. Samples were analyzed for their particle size distribution. City street D&D was collected in large quantities, similarly processed and reconstituted into the same fractions found on the permeable paver surface. Tests were then conducted on the special outdoor rig. Synthesized D&D and artificial, intense rains were systematically applied to the pavement, and surface and subsurface drainage flow rates measured. Four different PICPs were tested and drainage cell, bedding and base material throughout the test pavement were sampled and analyzed. Typical results are shown in Figure 6 and indicate the rate at which the synthesized D&D (SD&D, denoted *sediment* in Figure 6) may clog the drainage cells of PICP.

Change in the performance (infiltration rates) of the permeable pavers as a result of the SD&D application did not begin immediately. Quantities of SD&D that can be applied without causing a decline in performance of the pavers are evidently determined by the net porosity of the combined drainage cell fill material and applied SD&D. After the application of 1.4 kg/m² of road SD&D, the average infiltration rate at the paver surface declined to a rate below the inflow rates (using a 1 in 25 y design storm of 5 min duration and intensity of 230 mm/h). More frequently observed rainfall events with lower rainfall intensities might produce different results. After the accumulation of 3.9 kg/m² SD&D, the drainage cell material became functionally clogged. However, over a large section of permeable pavers, heterogeneity of the infiltration rates over different sections may sustain the performance of the pavers for some time. PICP should be properly maintained when there is a risk that the surface is affected by partial clogging. This should correspond to the accumulation of between 1.4 kg/m² and 3.9 kg/m² SD&D for the conditions of their experiment. James recommended that his results be compared to similar experiments using different drainage cell and base materials of varying porosity, and using different rainfall intensities and durations. Also, in future experiments, SD&D remaining on the surface should be carefully measured, to formulate a SD&D balance, and help determine SD&D pathways and fate.

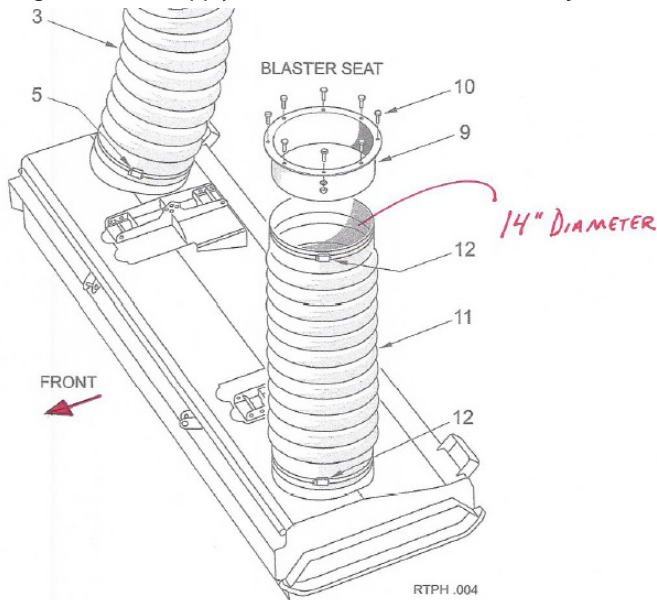
Figure 7 Pick-up head, detail (source: Johnston Street Sweepers, AMACO Canada).

For these reasons we decided to proceed with laboratory scale demonstrations of the basic fluid mechanics in various geometries of RCPPs, as they are swept and cleaned by a simulated pick-up head with similar air flow patterns and speeds to those of real, full scale machines—earlier work reviewed above suggested the suitability of regenerative air street sweepers, now the second most popular equipment, for which engineering details are provided in Figures 7 and 8, courtesy of Johnston Street Sweepers, and AMACO Canada. Air flow rates for such equipment is approximately 20 000 ft³/min (566 000 L/min). In the rig developed for this paper, at an airflow of 200 ft³/min (5 660 L/min) air velocities in the simulated pick-up head are matched by scaling down the length of the air supply slot (sometimes termed the *blast jet*).

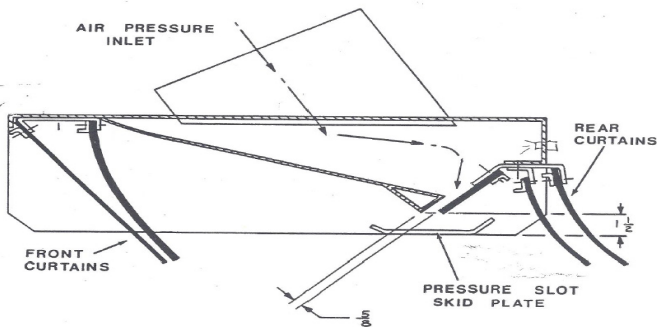
**PICK - UP NOZZLE
LEFT SIDE CUT-AWAY**

Figure 8 Cross section, regenerative air pick-up head (source: Johnston Street Sweepers, AMACO Canada).

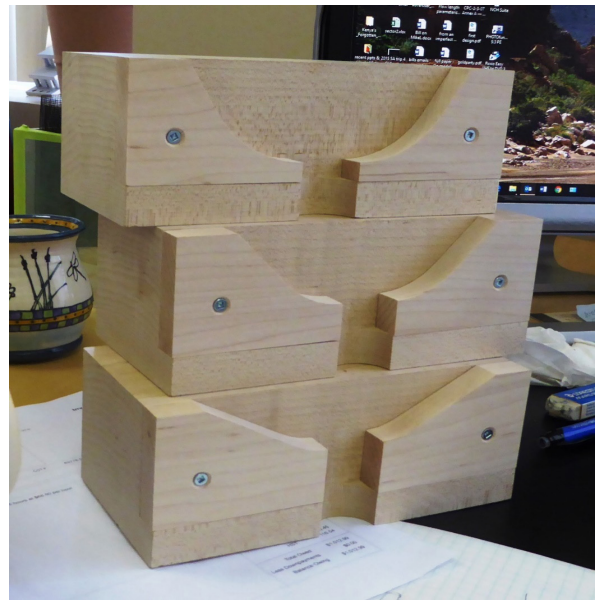
Figure 9 Several test PICPs.

Fully dimensioned AutoCad drawings of the components of the rig, see Figure 14 below, and of the RCPP test specimen, are attached as files to this online paper. Briefly, a number of test RCPPs were machined in clear poplar, as shown in Figures 9 and 10. A single RCPP was inserted in the rectangular plexiglass ampule (housing) shown in Figure 11. Bedding, conduit and cupule filter media were poured into the ampule, the RCPP tamped down and the assembly paced in the test rig, as depicted in Figure 12. Connected to the regenerative air source, the test pick-up head passed over the RCPP at speed, as can be discerned from Figure 13. Figure 14 shows a test version of one regenerative air pick-up head, which simulated the fluid mechanics of a pick-up head by manufacturer J.

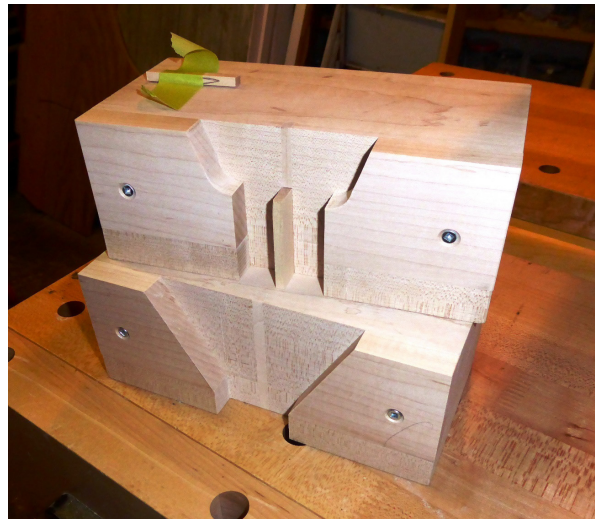
Figure 10 Further test PICPs.

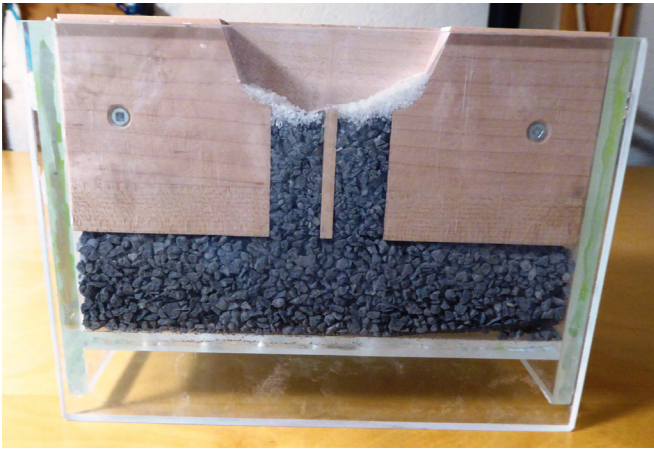
Figure 11 Test block with filter media in the ampule.

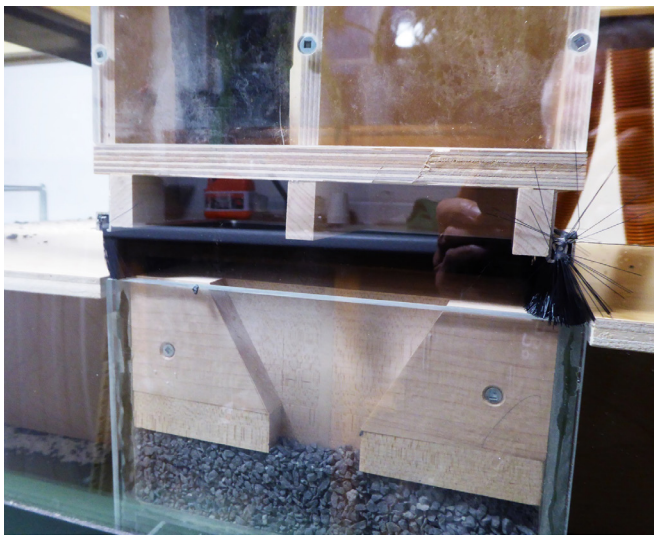
Figure 12 Loaded ampule positioned in test section of the rig.

Further tests in the laboratory rig showed that, for the chosen geometries, virtually complete removal, $S \approx 1.0$, or even excessive removal, $S \geq 1.0$, is easily achieved at almost any reasonable speed V . Figure 12 above shows one such result.

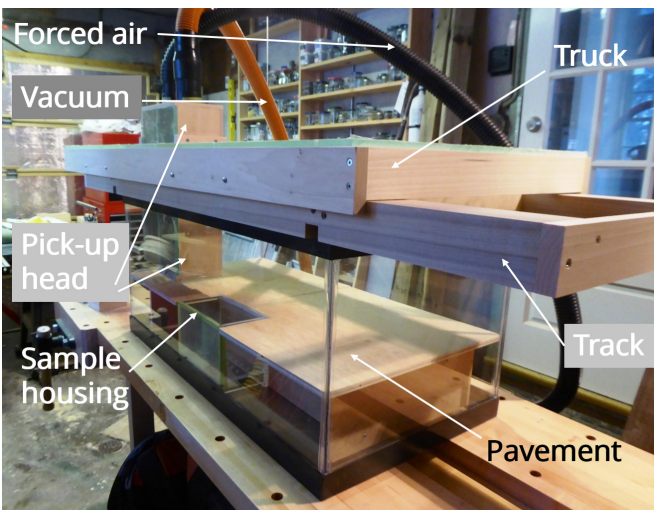
Figure 13 Rig, general arrangement.

A slow motion video with timing (available from CHI) clearly illustrates the flow patterns of the ejected filter media as the pick-up head passes over the test section, with vacuum leading and blast air jets following. The first pass ejects a slightly greater volume of media than in the cupule, and the return pass does not significantly remove further media. From the timing we calculate the horizontal truck speed as 800 m/h or slightly under 1 km/h.

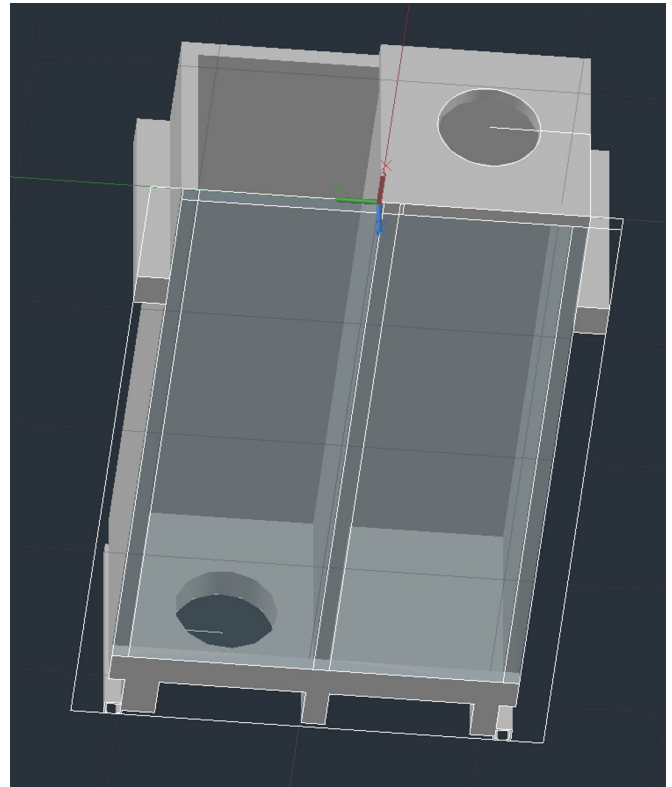
Figure 14 Schematic outline for test pick-up head J (some details missing).
